NBSIR 78-1530

Mobile Home Living Room Fire Studies: The Role of Interior Finish

Edward K. Budnick

Interim Report

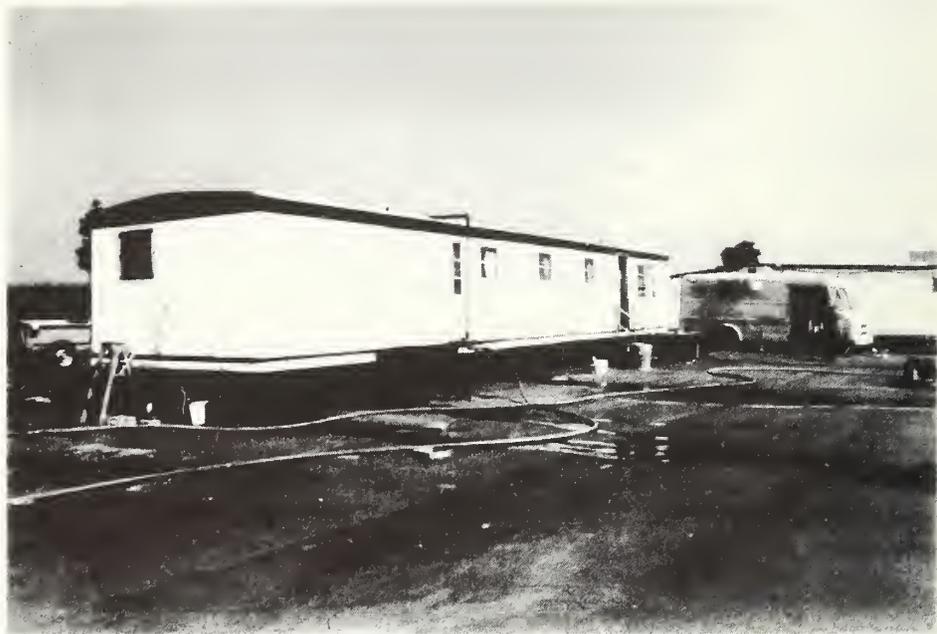
Figure 1. Illustrations of Typical Single-Wide Mobile Homes Used in Conducting Full-Scale Fire Tests.

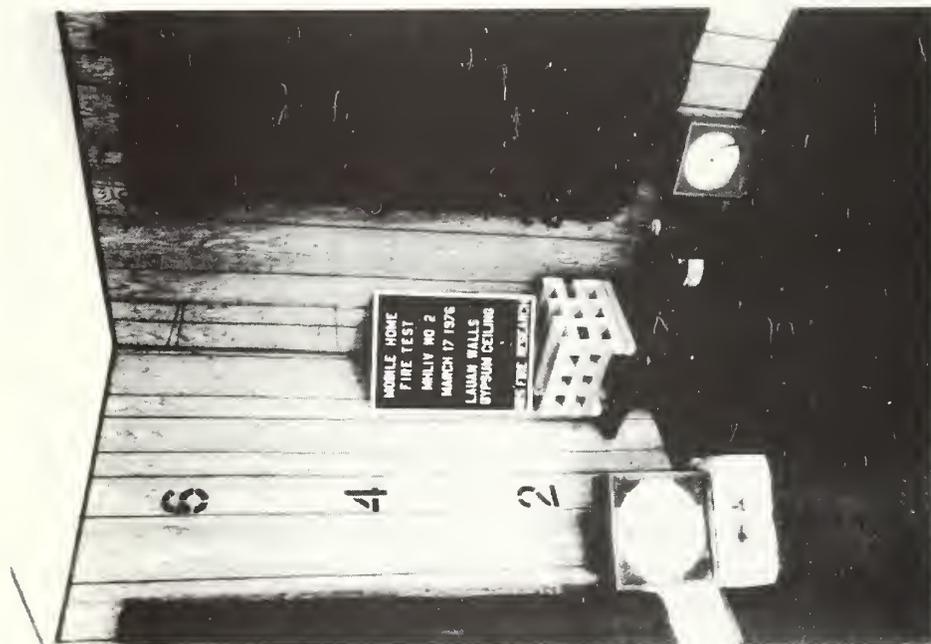
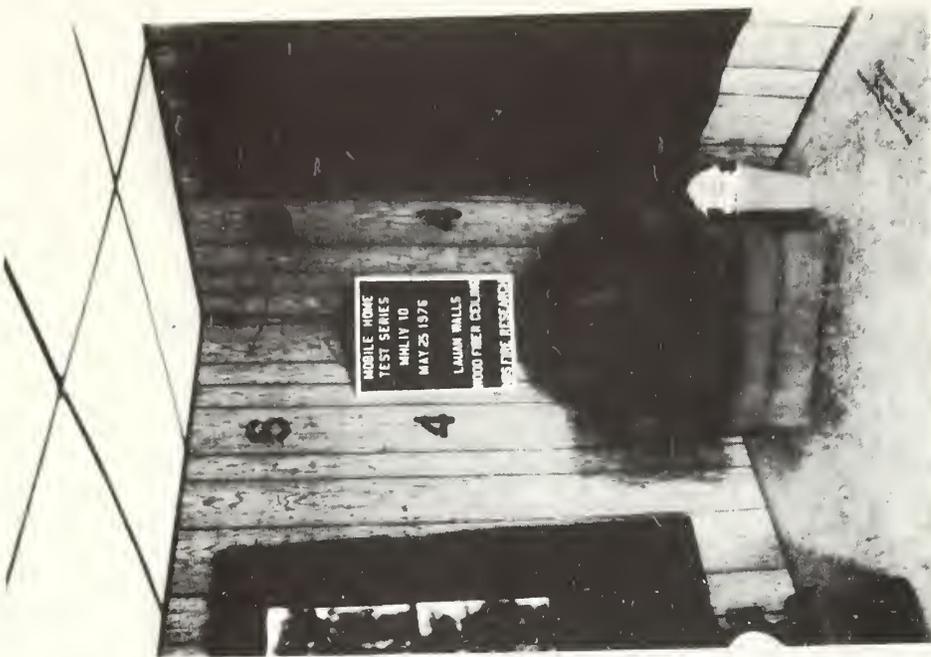
Figure 5a. Wood Crib

Figure 5b. Upholstered Chair

Figure 5. Illustration of Typical Test Set-Up; Location and Positioning of Initial Burning Items.

In those tests using the upholstered chair as the initial burning item, the chairs, having an approximate weight of 16 kilograms (35 lbs) were positioned on the load cell platform, again in the northwest corner with the back of the chair approximately 25 mm (1 in) from the walls comprising the corner. The chairs were ignited by placing a commercially available 9ℓ (9.5 qt) capacity polyethylene waste container containing 225 gm (8 oz) of crumbled newspaper adjacent to the left arm of the upholstered chair and igniting the newspaper. (Figure 5 illustrates the two initial burning items and their position in the corner configuration.)

Test 16 provided information on the fire growth from a 16 kg (~35 lb) upholstered chair in a corner configuration in the mobile home when the same noncontributing walls and ceiling were installed. In this test, the construction was identical to test 15, exposing walls and surfaces constructed of 13 mm (1/2 in) thick calcium silicate panels to the chair fire. The upholstered chair was exposed to a low intensity fire started in a 9ℓ (9.5 qt) capacity polyethylene waste container containing 225 gms (8 oz) of crumbled newsprint placed adjacent to the left arm of the chair (figure 5b). The newsprint was ignited on the top surface by remote electrical ignition of a wooden match.

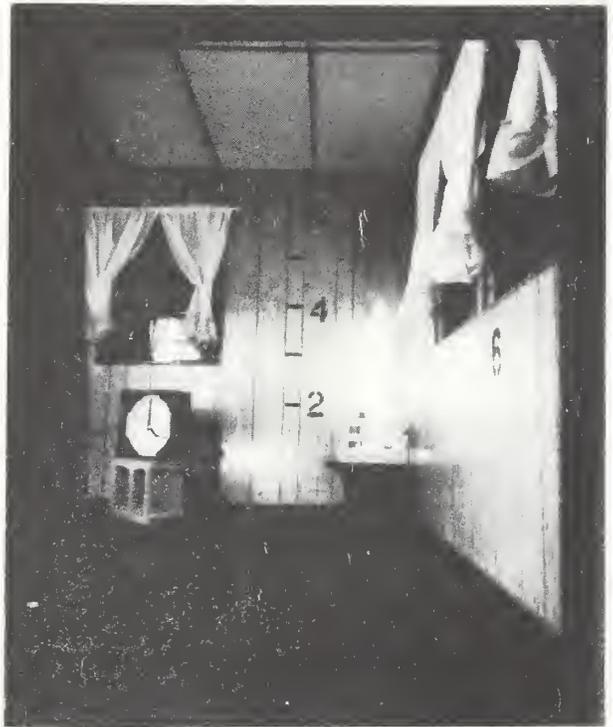
Photo 1. Flame localized in center of wood crib (37 sec. elapsed).

Photographs 1 through 7 illustrate fire build-up and resulting damage in Test #1 with 4 mm thick prefinished lauan plywood walls and 13 mm thick cellulosic fiber ceiling.

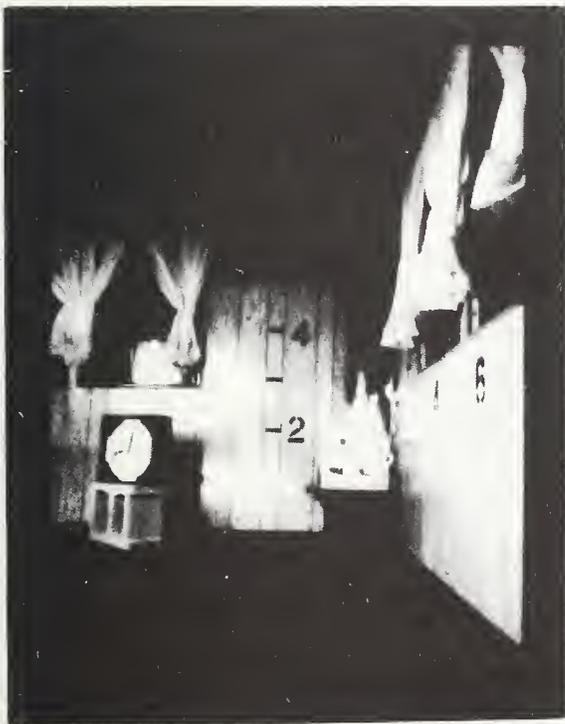
Photo 2. Ignition of wall material (1:44 min. elapsed).

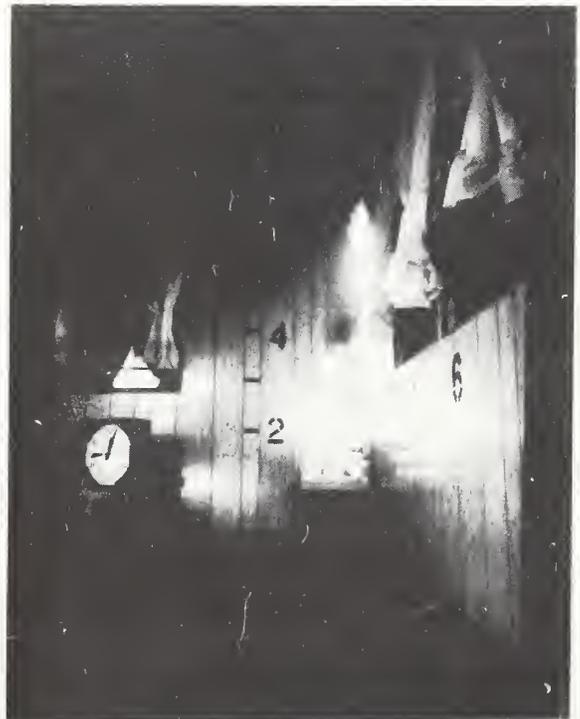
Photo 3. Extension of flame towards ceiling (2:45 min. elapsed).

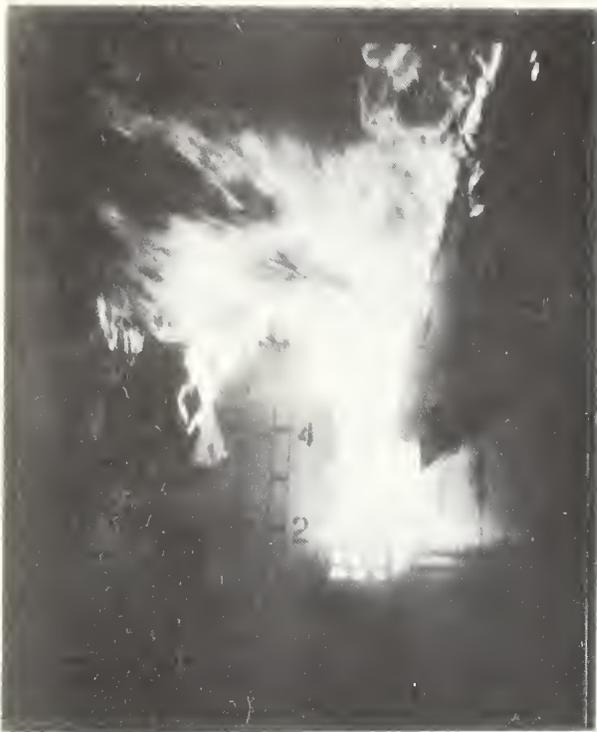
Photo 4. Advanced flame propagation across ceiling (3:19 min. elapsed).

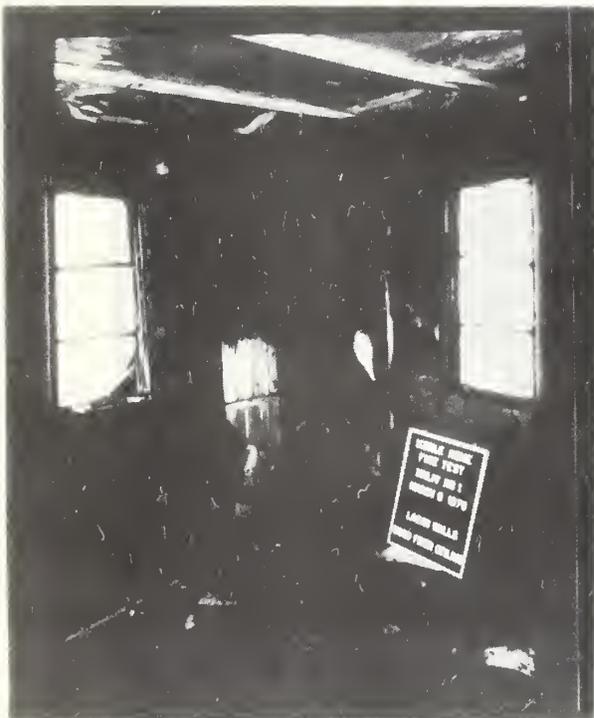
Photo 6. Damage in corner; illustrates burn-through to exterior and damage to structural members and insulation.

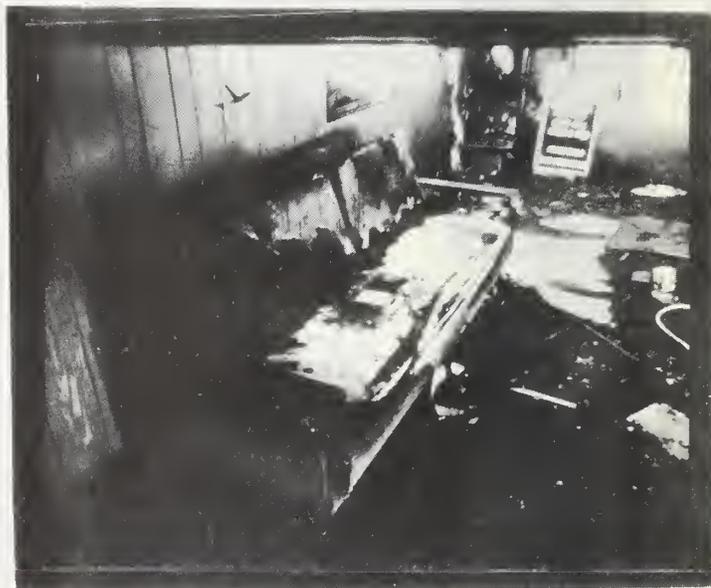
Photo 7. Illustrates extent of damage in living room including sofa which ignited during flash-over.

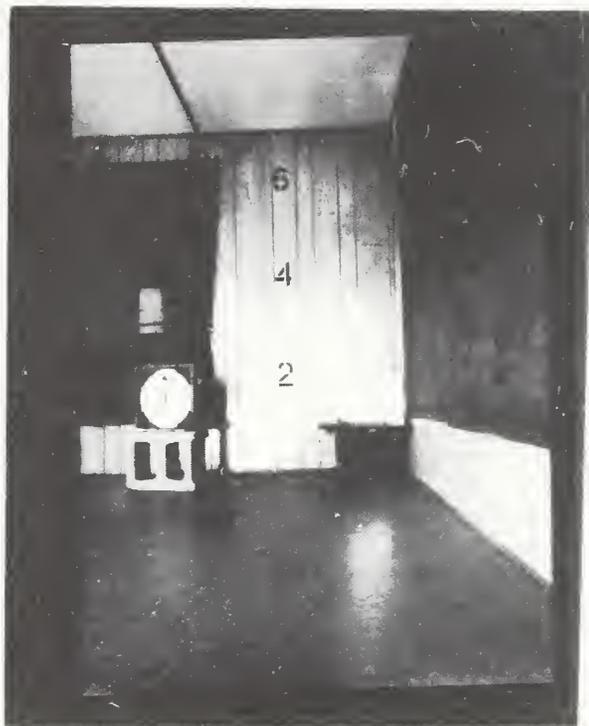
Photo 8. Initial burning of wood crib (10 sec. elapsed).

Photographs 8 through 14 illustrate fire build-up and damage occurring in Test #2 with 4 mm thick prefinished lauan walls and 8 mm thick prefinished gypsum board ceiling.

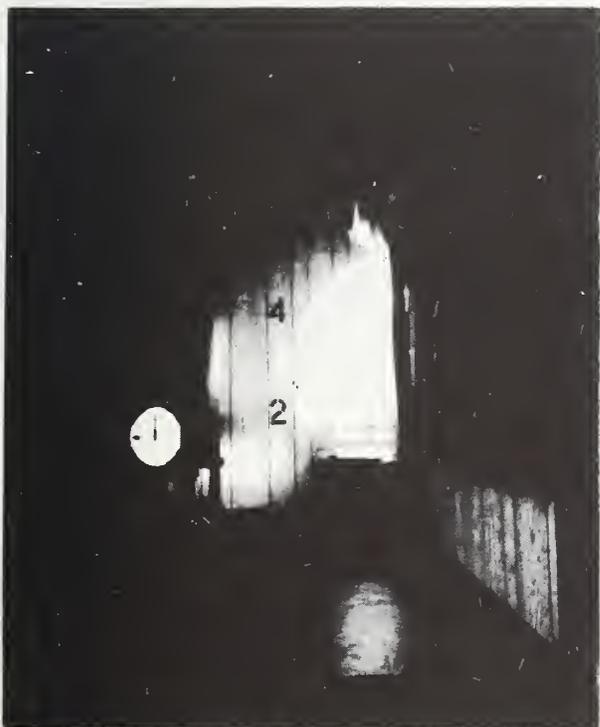
Photo 9. Involvement of wall material and extension of flame towards ceiling (50 sec. elapsed).

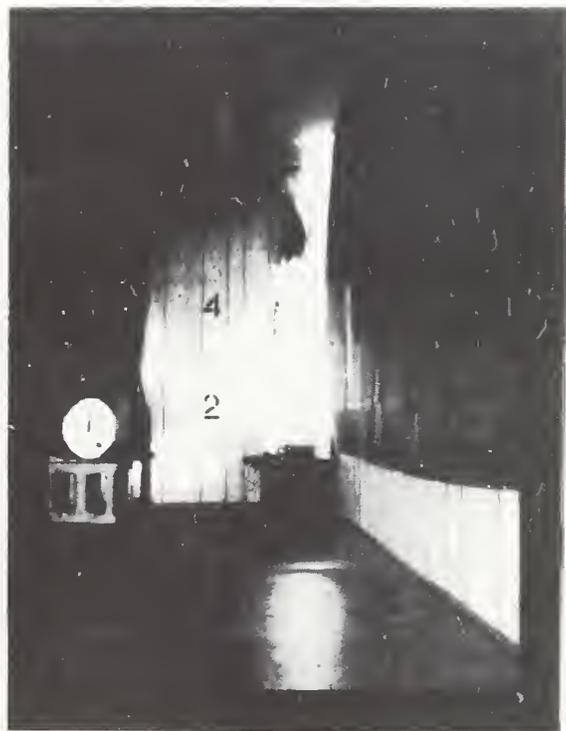
Photo 10. Flame impingement at ceiling (1:30 min. elapsed).

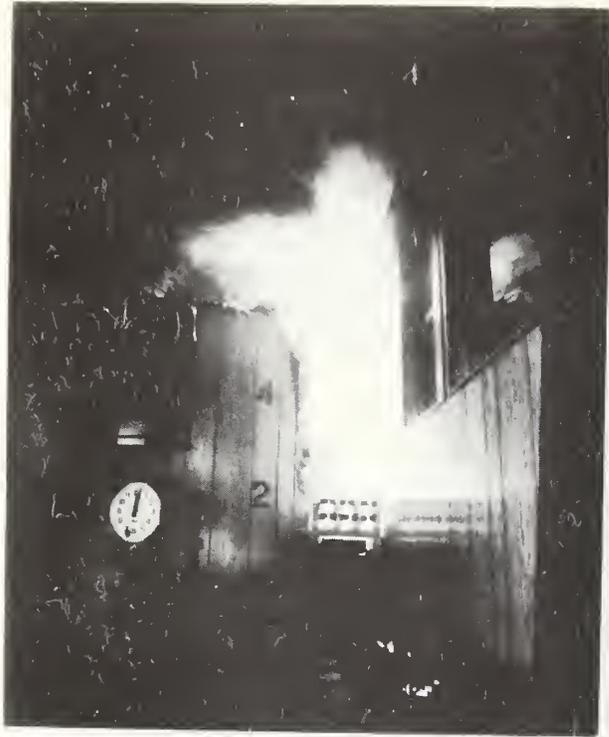
Photo 11. Increased involvement of walls and lateral propagation of flames along the ceiling. (2:38 min. elapsed)

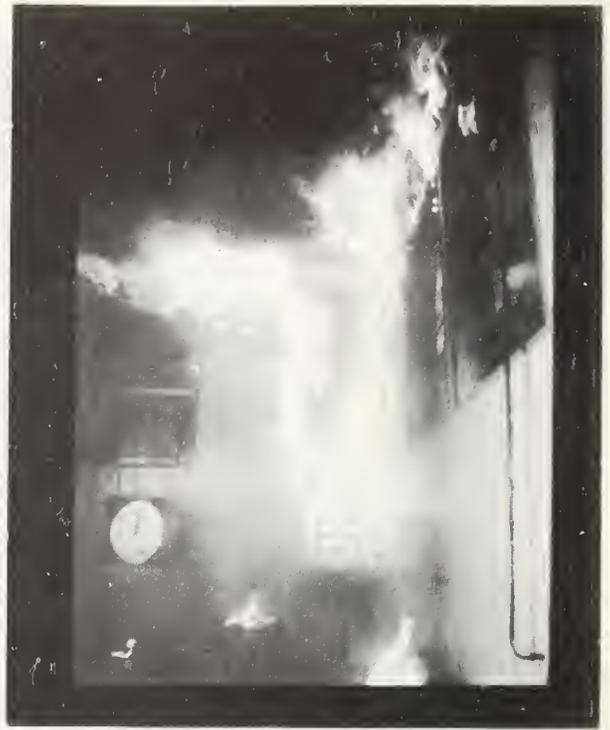
Photo 12. Burning of upper walls along ceiling (3:31 min. elapsed).

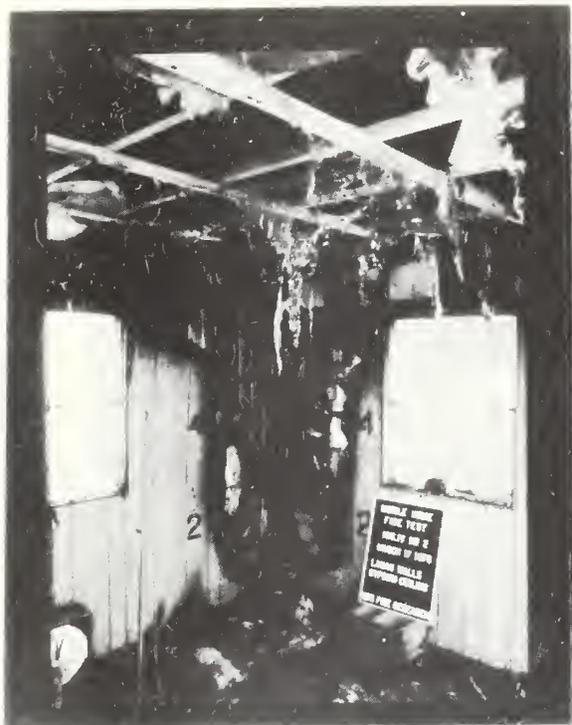
Photo 13. Illustrates damage in corner including burn-through of walls and charring of structural members.

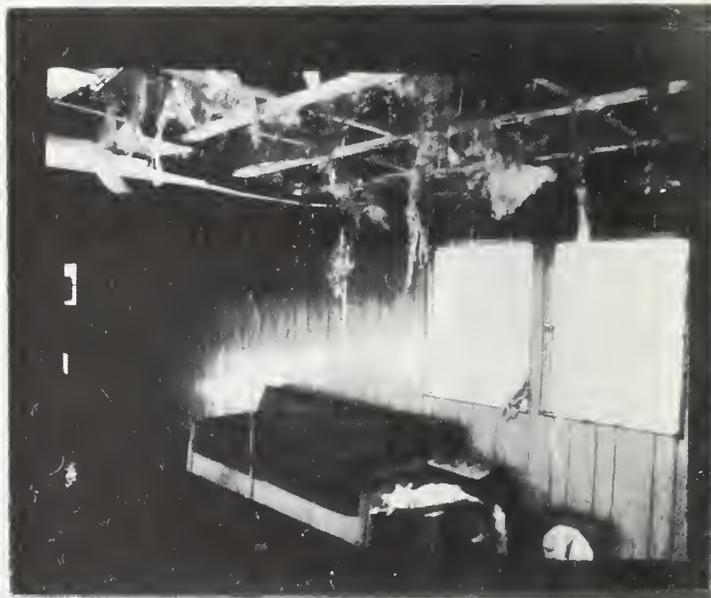
Photo 14. Illustrates damage in living room. Ceiling has been removed to observe the extent of damage.

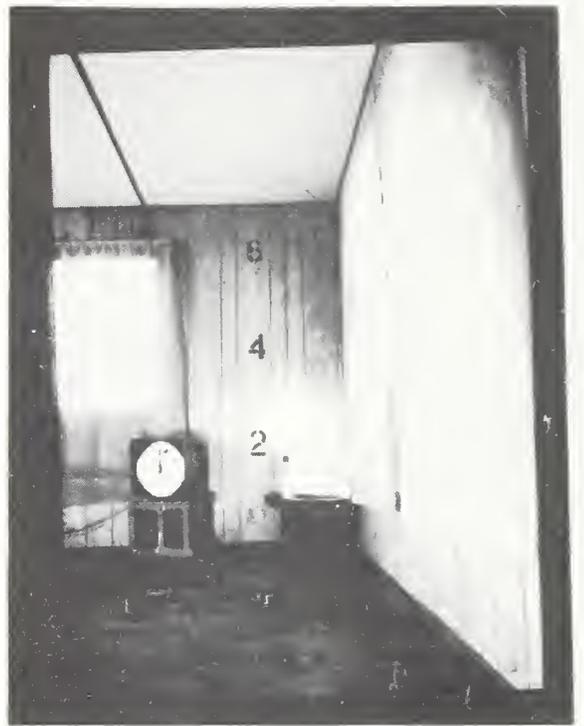
Photo 15. Initial burning of wood crib (13 sec. elapsed).

Photographs 15 through 21 illustrate fire build-up and damage occurring in Test #4 with 4 mm thick fire retardant treated walls and 8 mm thick prefinished gypsum board ceiling.

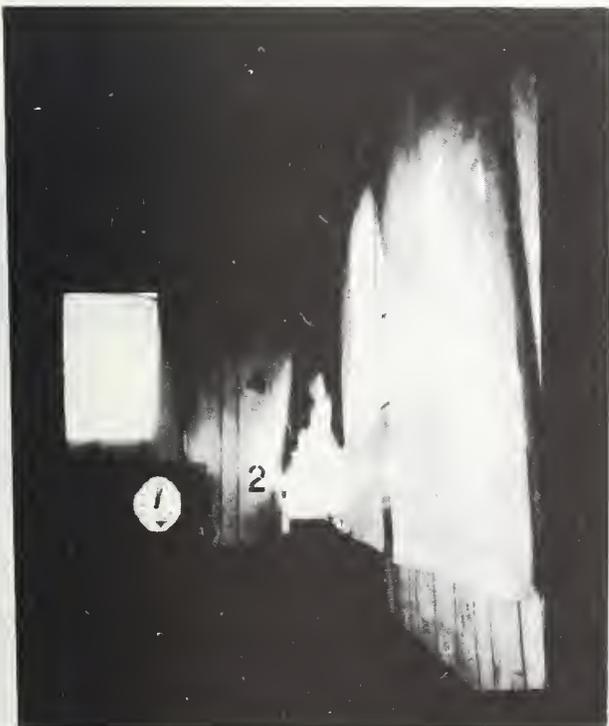
Photo 16. Fire localized to burning wood crib. Charred area in corner indicates intumescing of surface treatment (3:35 min. elapsed).

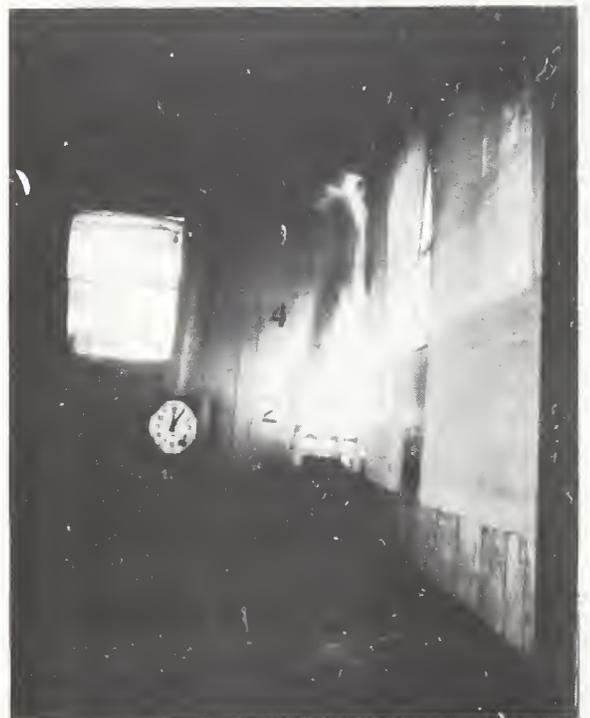
Photo 17. Burning of molding in corner; flame extension to ceiling. (4:01 min. elapsed)

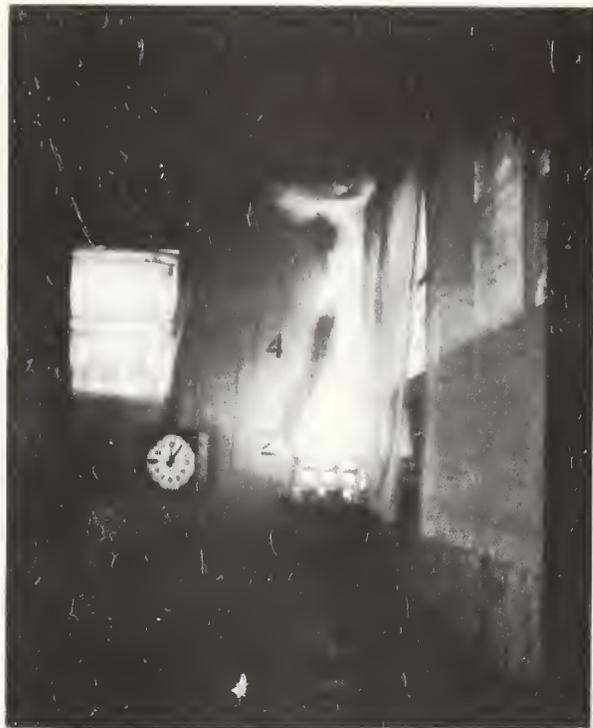
Photo 18. Wall is involved; flames have extended slightly along ceiling (5:53 min. elapsed).

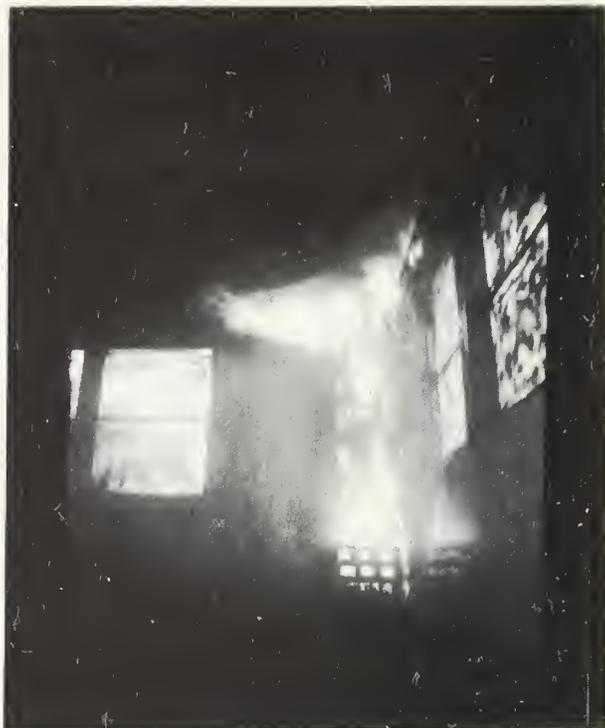
Photo 19. Crib fire has reduced in intensity; wall material continues to burn and flames have extended laterally along ceiling (8:35 min. elapsed).

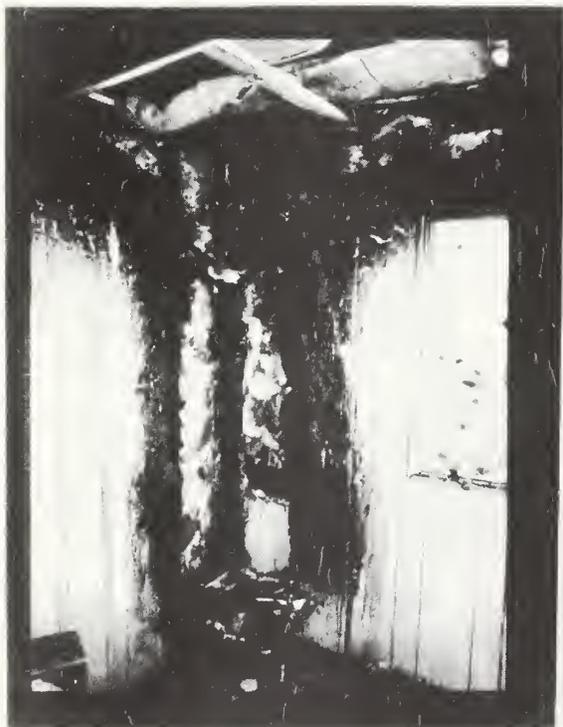
Photo 20. Illustrates damage in corner including burn-through of walls and extensive charring along ceiling. Minor damage observed above ceiling.

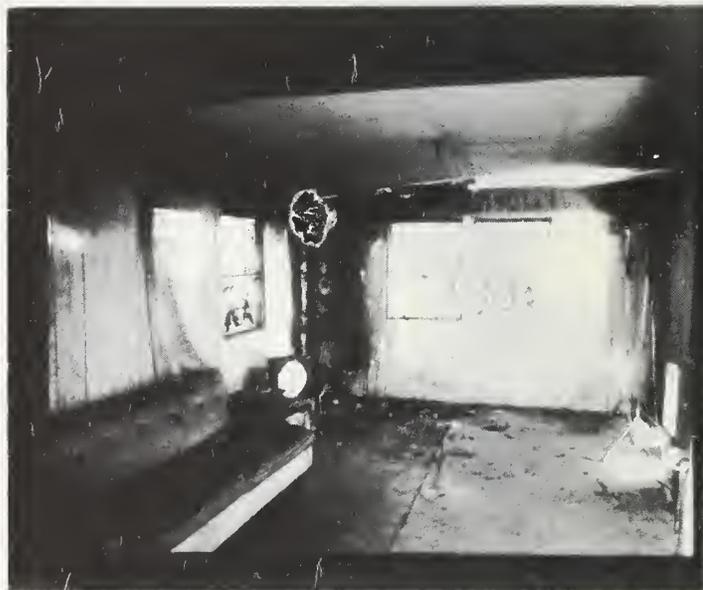
Photo 21. Illustrates damage to corner in living room and charring of upper walls along ceiling.

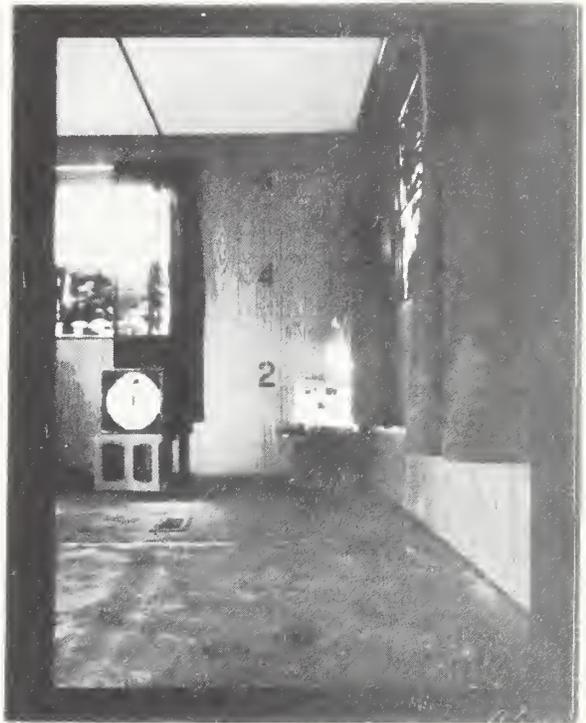
Photo 22. Initial burning of wood crib (5 sec. elapsed).

Photographs 22 through 28 illustrate fire build-up and damage occurring in Test #6 with 8 mm thick gypsum board walls and ceiling.

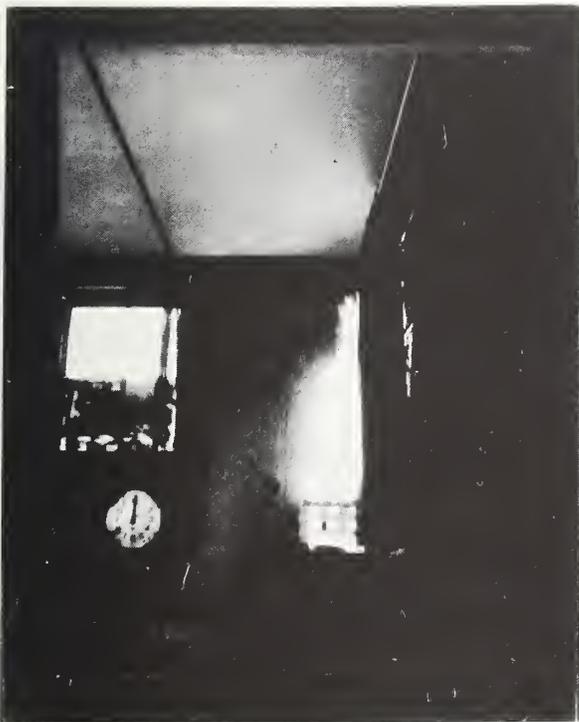
Photo 23. Burning of the paper surface on the wall. Flame has reached maximum size (4:18 min. elapsed).

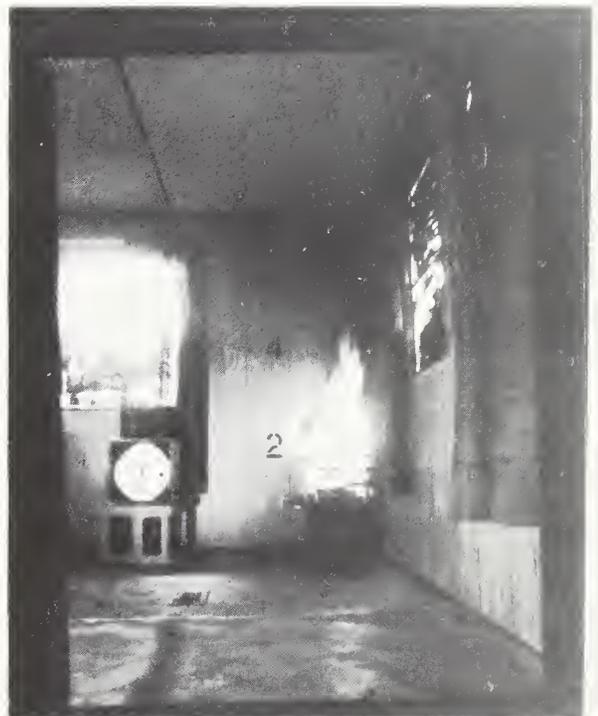
Photo 24. Continued burning of wood crib; no contribution from interior finish (4:18 min. elapsed).

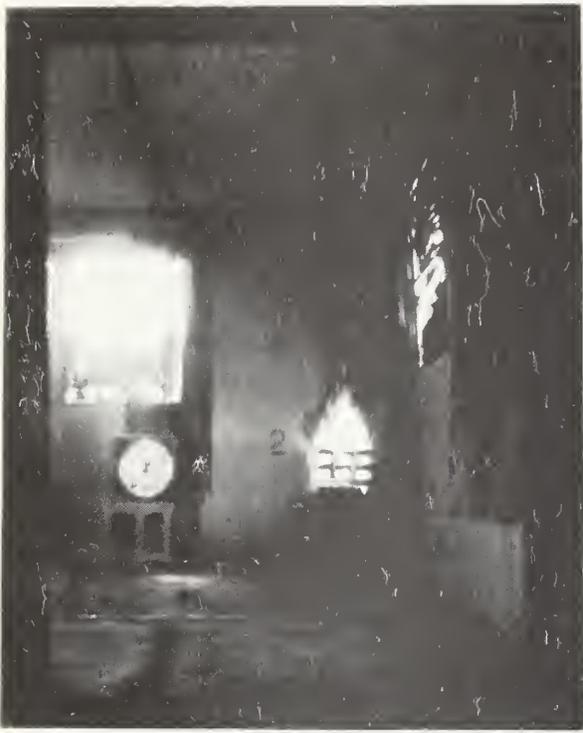
Photo 25. Wood crib continuing to burn at nearly a constant burn rate (6:39 min. elapsed).

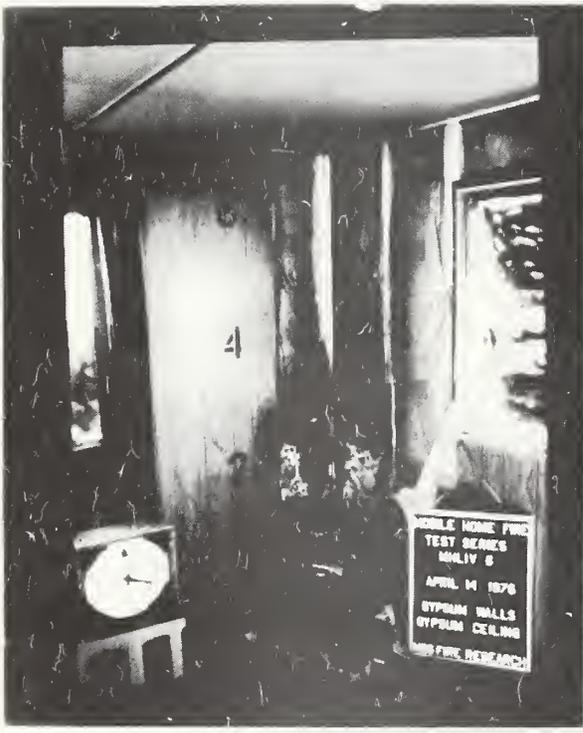
Photo 27. Illustration of damage in corner. Charring of insulation and structural member due to penetration of wall material along a vertical joint.

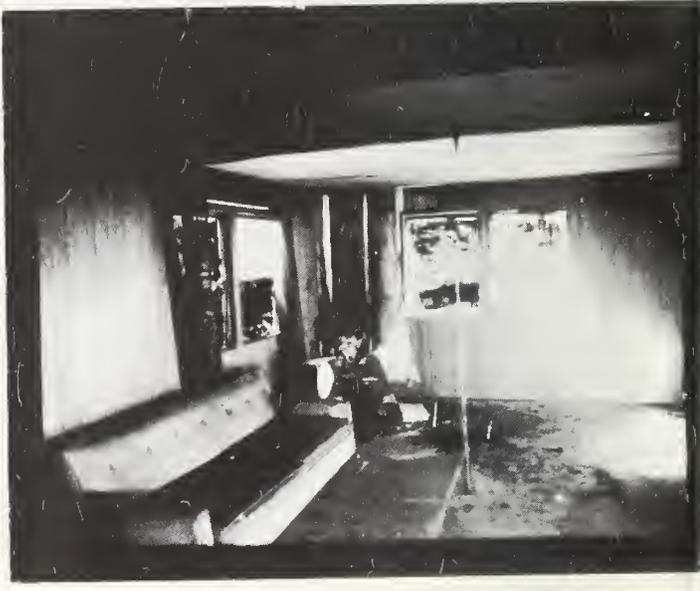
Photo 28. Illustrates limitation of damage to corner in living room.

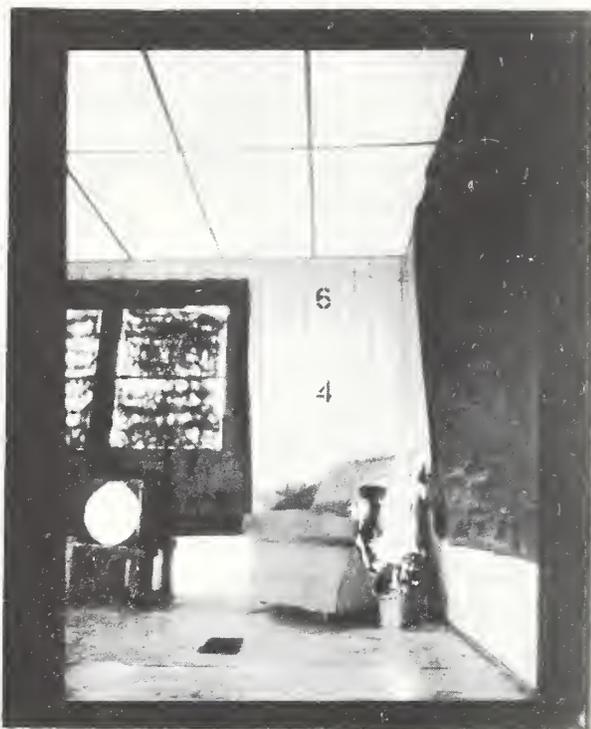
Photo 29. Initial fire localized to waste container and left arm of chair (50 sec. elapsed).

Photograph 29 through 35 illustrate fire build-up and damage occurring in Test #10 with 4 mm thick prefinished lauan plywood walls and 13 mm thick cellulosic fiber ceiling.

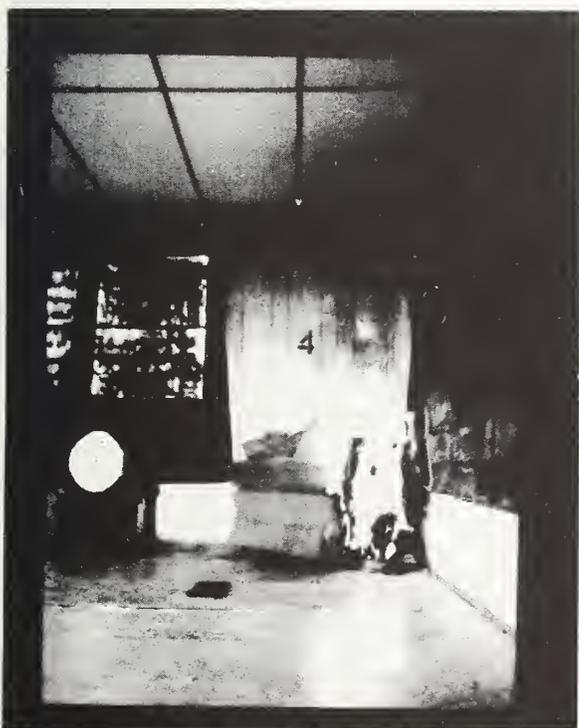
Photo 30. Waste container nearly destroyed. Increased involvement of chair (8:55 min. elapsed).

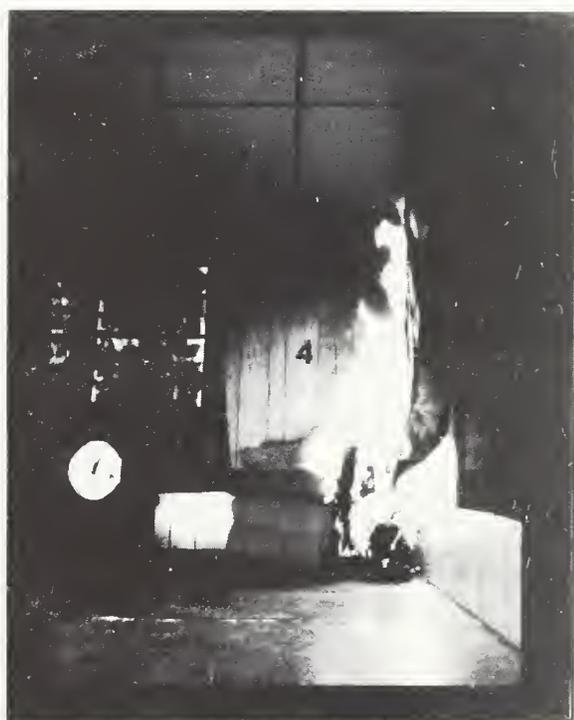
Photo 31. Wall material involved. Flame extension to ceiling (4:05 min. elapsed).

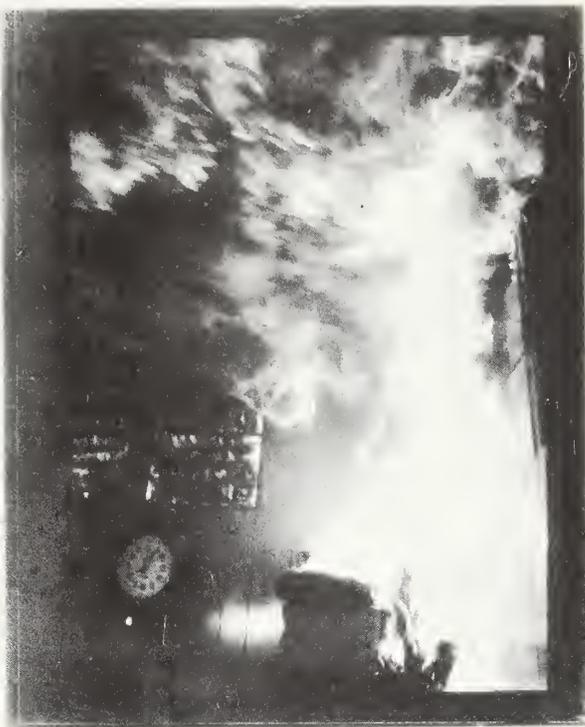
Photo 32. Extensive propagation along upper walls and across ceiling (4:55 min. elapsed).

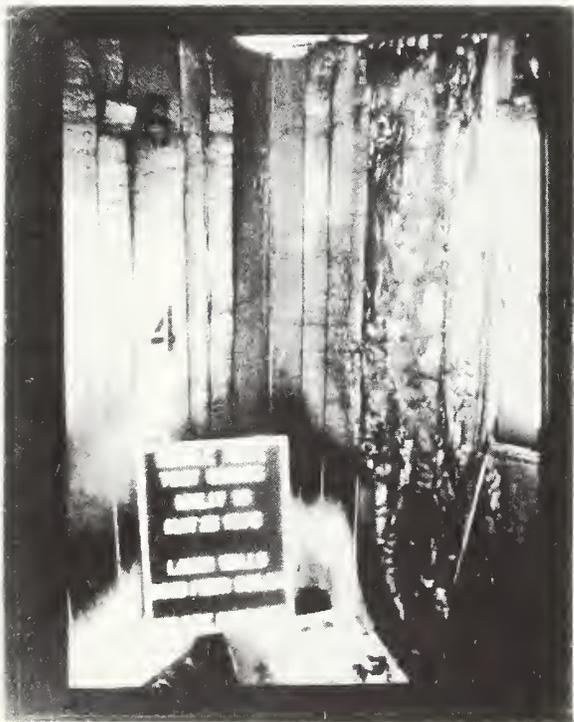
Photo 34. Illustration of damage in corner. Burn-through of wall in corner; charring damage to ceiling material.

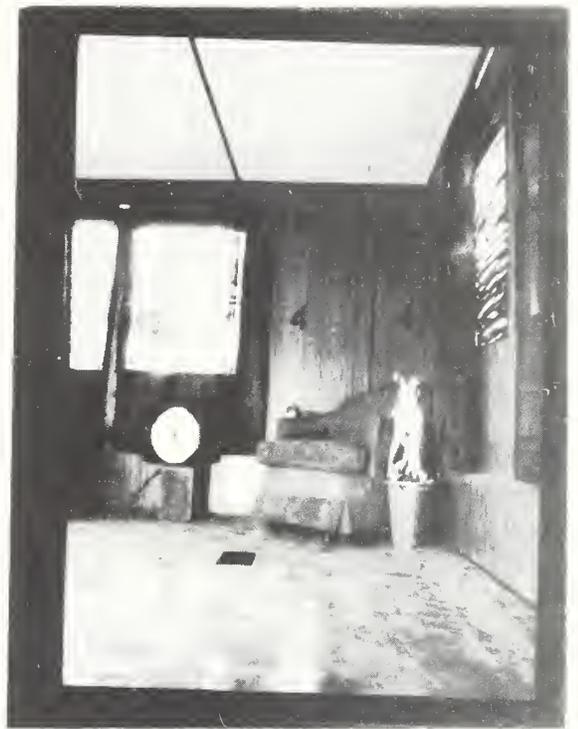
Photo 36. Initial fire localized to waste container and left arm of chair (53 sec. elapsed).

Photographs 36 through 42 illustrate fire build-up and damage occurring in Test #11 with 8 mm thick prefinished gypsum walls and ceiling.

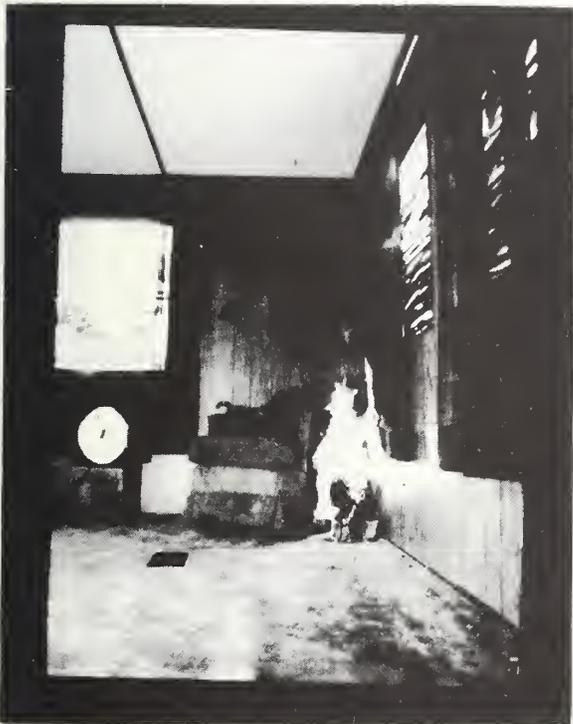
Photo 37. Waste container melting; increased involvement of arm of chair; burning of curtain and wall surface (4:58 min. elapsed).

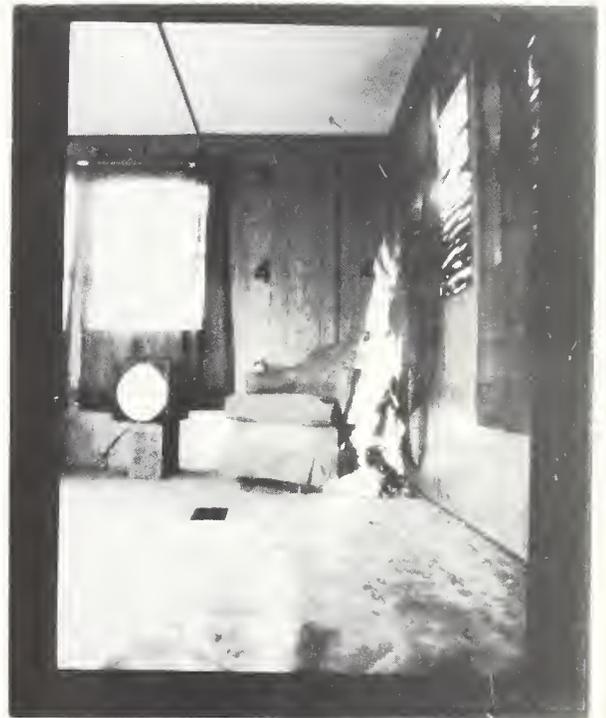
Photo 38. Increased intensity of chair fire; flames approaching ceiling. (9:55 min. elapsed)

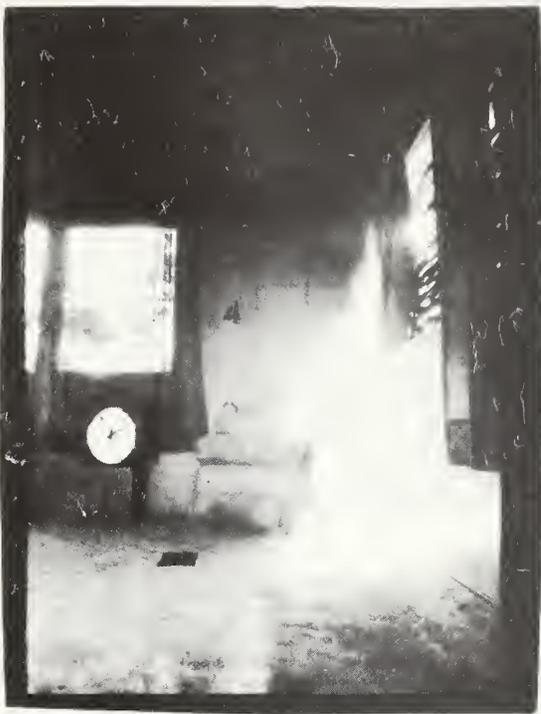
Photo 39. Chair fire has reached maximum intensity; flame impingement on ceiling. (11:42 min. elapsed)

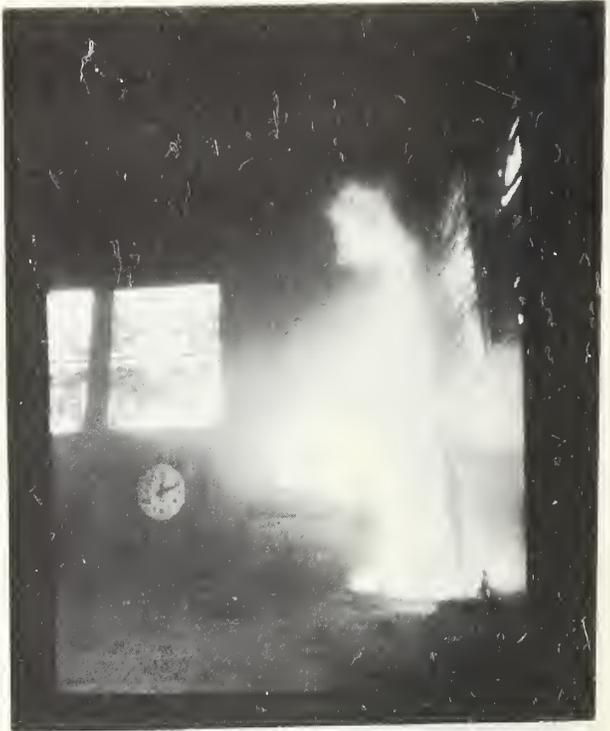
Photo 40. Reduced intensity of chair fire; no involvement of interior finish; noticeable smoke accumulation (13:30 min. elapsed).

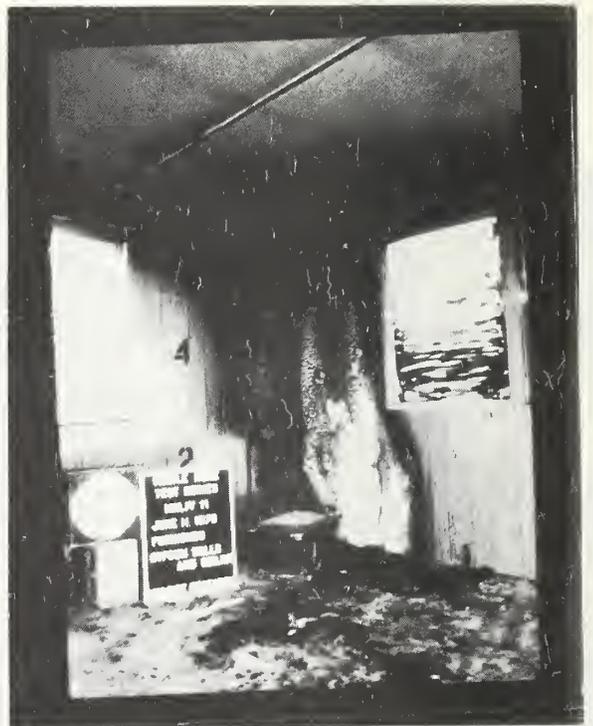
Photo 42. Illustrates damage to interior finish—confined to corner; no involvement of other combustibles.
